# Accident Investigation Nevada 2020

Date of accident: 22 August 2020

Glider: Ozone Zeno L

Ozone Zeno L serial: ZENL-R-47A-045 manufactured in January 2017.

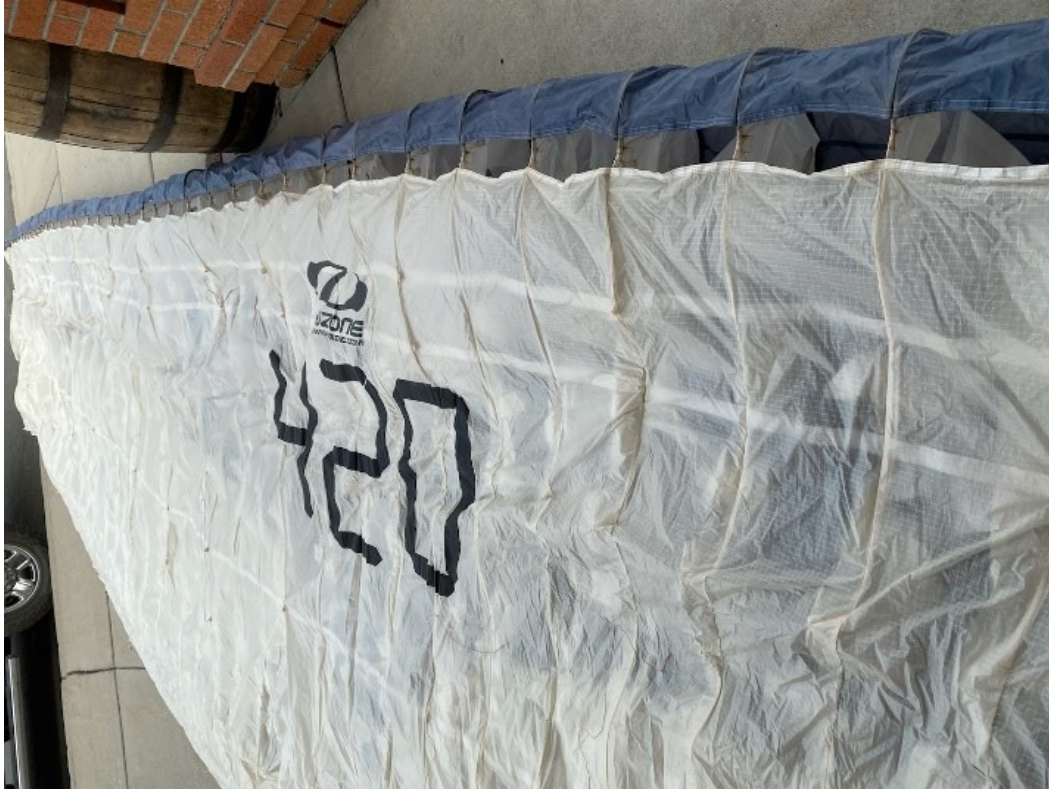
Despite 3 seasons of flying and having spent 25 days exposed in the desert, the cloth is still in relatively good condition. The average lower surface porosity reading is 73 seconds with a tear strength of 1000g (5mm tear measured with a Bettsometer). The upper surface leading edge has an average porosity of 239s and a similar tear strength of 1000g.

In terms of porosity and tear strength, we would consider the sail to be in an airworthy condition.

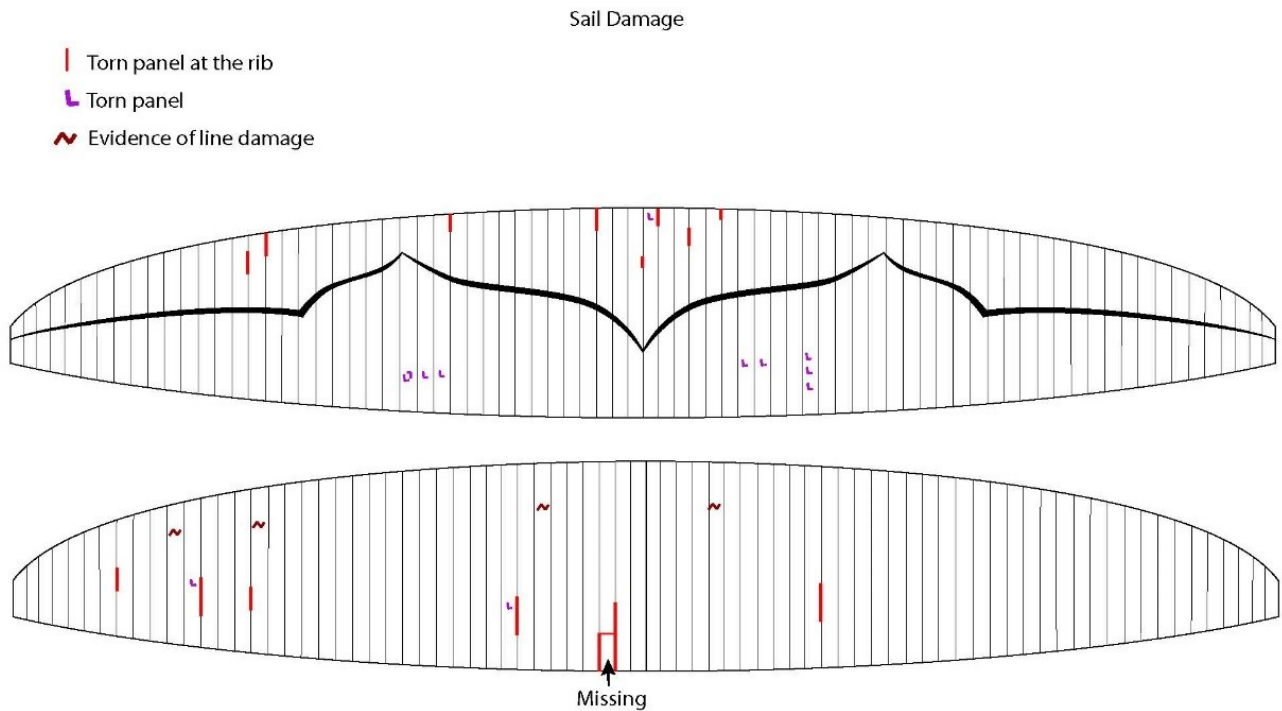
The leading edge shows signs of friction wear near the plastic reinforcements on most of the ribs, this is probably due to the age and natural use of the wing. 6x upper panels were torn in this area (identified by the red line in the diagram below), we believe this was caused by excessive tension running through the leading edge as a result of the initial line failure/ high g spiral dive.

There are multiple small tears and puncture marks in the upper and lower panels. We do not believe these contributed to, or were a consequence of the incident and probably occurred during the 25 days in the desert.

3x C line attachment tabs have been pulled out of the sail completely, one of which pulled out a portion of the panel from the tab to the trailing edge (marked missing in the diagram above, photo below). The C line attachment tabs are not heavily reinforced as they are not normally subjected to significant loads. All of the load bearing A and B line attachment tabs are still in place on the wing.

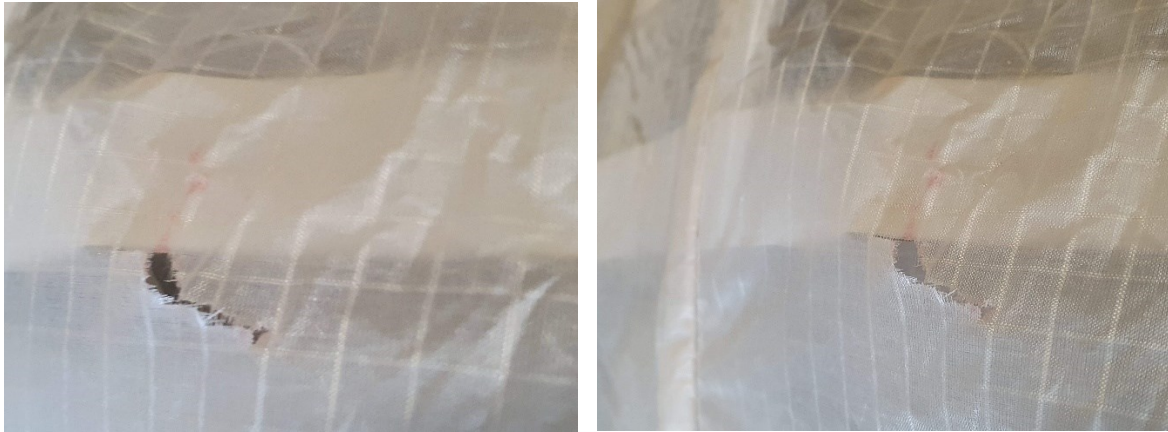
A few lower surface panels exhibit evidence of serrated tears caused by line damage, identifiable by the red marks left by the lines in the area of the tear. These marks are typical evidence of line failures after extremely high loads and are caused by the whiplash effect of the broken lines. We regularly observe exactly the same type of damage on wings that have been subjected to a destructive load tested. See photos below:

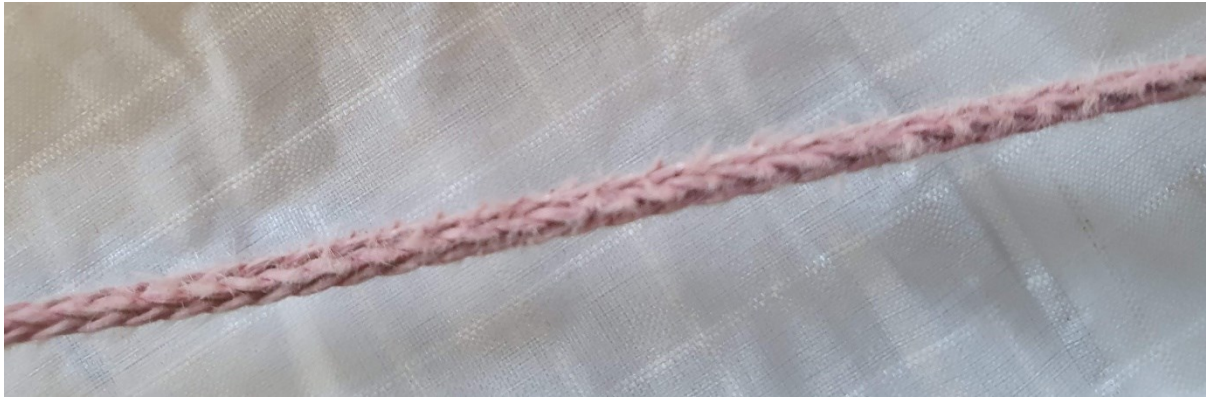
However some of the main riser lines (lowest line level) are seriously worn by friction a few cm above the risers (left side: AR1, AR2, AR3, BR2, BR3).

This type of damage indicates a strong possibility of a “twisted line” incident. Broken fibres and discolouration caused by excessive frictional forces during a twisted spiral can significantly reduce the strength of individual lines.

Alternatively, this damage may have occurred before the flight by dragging across rocks or being accidentally stood upon, but in our opinion these are hallmark signs of stress caused by a twisted spiral.

3x of the riser lines of the left-hand side broke in the friction damaged area (AR2, AR3, & BR2). We believe these were the first lines to break during the incident and caused the remaining lines to fail. BR3 broke higher up, suggesting it was damaged by the whipping effect of one of the initial lines to fail.

- After any cascading incident involving riser/line twists, you should presume the lines are weakened and in need of replacement. This is especially important for those flying high end EN D / CCC competition 2 liner wings with unsheathed line sets.

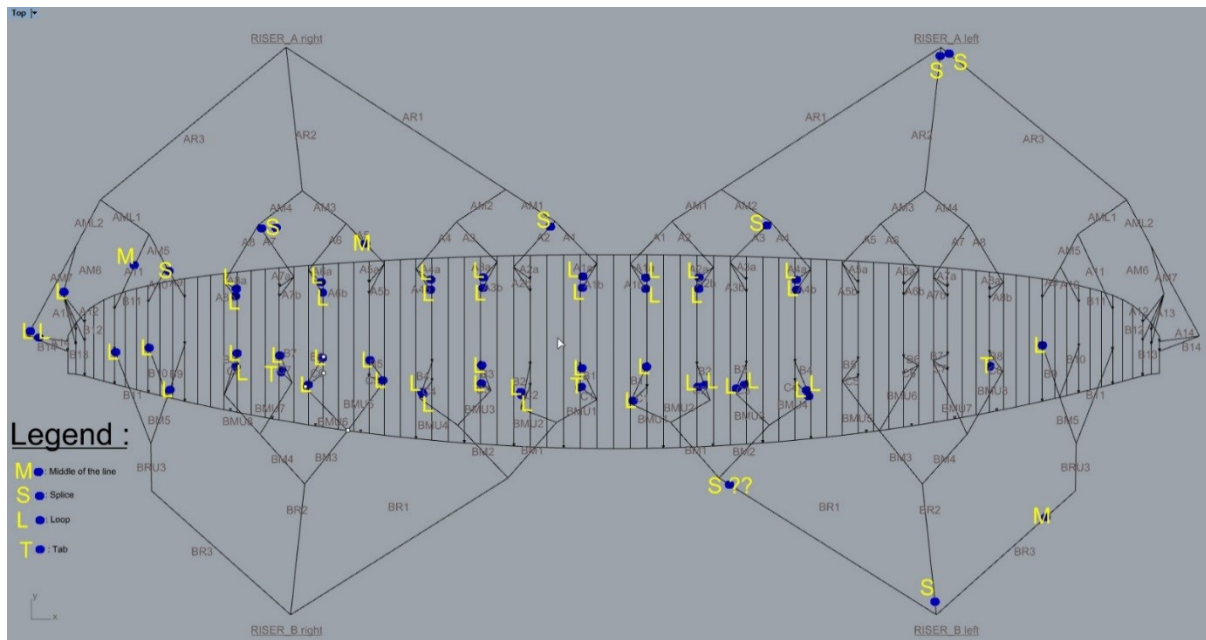
BR1 of the left hand side broke in an unusual way – all of the upper lines corresponding to it broke close to their attachment tabs, which must of happened before BR1 itself broke (see S?? in the diagram below). We believe BR1 was either broken by the whipping effect, or during the impact with the ground. It was not one of the initial lines to break.

Of the remaining lines, the failure occurred mostly in the upper gallery, with a few mids failing instead. This is a typical failure pattern seen during extremely high loads and have been observed during EN 926-1 sustained load tests that lead to full destruction.

The normal pattern of a catastrophic line failure, observed with slow motion cameras during a load test is as follows: The initial failure is normally a main A or B riser line, immediately after this, the remaining riser lines along the same chord position fail and then the canopy detaches as the upper lines across the span/chord fail one by one, in a very fast “unzipping” action. This type of failure is only likely under extremely high sustained loads. We have never seen this type of failure during a dynamic shock test, so in this case, the point of total line failure was, we believe, unlikely to have been caused by a violent reopening or a short fall past the lines, although it is impossible to rule this out completely.

50% of the upper lines broke at their line/attachment tab junctions. The remaining broke either at the loop at the other end (where they attach to the mid lines) or at the end of a splice – the weakest point - or the upper line remained intact and the mid line on the level below failed (see map above).

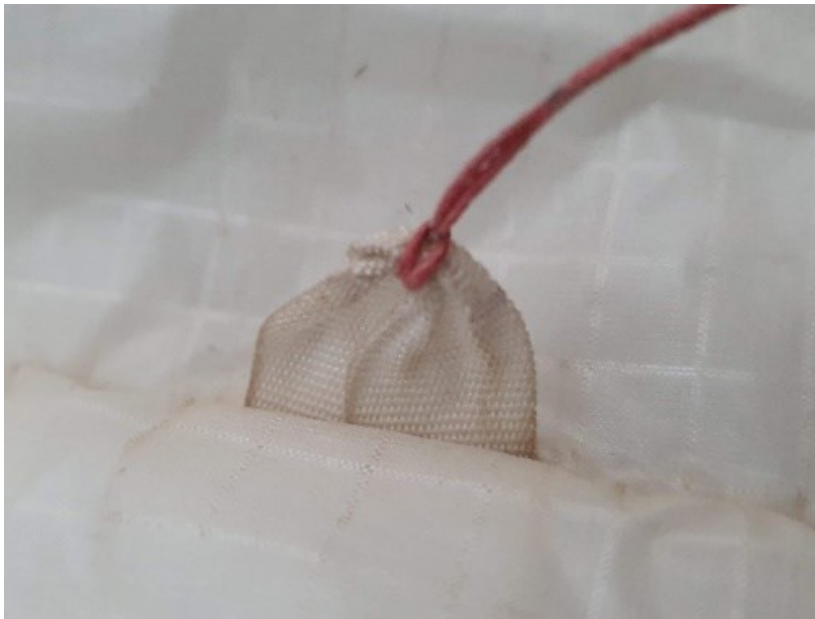
Of the upper lines still attached to the canopy, we can see that the vast majority were incorrectly mounted. See photo below.

We conducted a breaking test study on the line/attachment tab mounting with a static (sustained) and dynamic (shock) load to see the influence of the mounting method to the overall strength.

In total we broke 78 lines and using average values, the incorrect mounting results in:

- 8000U-090: no loss in static load, 31% loss in shock load.
- 8000U-070: no loss in static load, 27% loss in shock load.
- 8000U-050: 22% loss in static load, 25% loss in shock load.

In the tests we made, 8000U-070 and 8000U-090 lose more strength during a dynamic shock load than the 8000U-050. On the wing 87% of the 8000U-090 and 8000-070 (upper A lines) have broken at the tab junction while only 41% for 8000U-050. This also suggests there was a sudden peak in the already high sustained load and reinforces the “unzipping” scenario.

The incorrectly mounted lines may have been a contributing factor to the complete line failure, by facilitating the secondary unzipping failure.

- When re-lining a wing, ensure the lines are placed on the attachment tabs correctly. The loop of the lines must be held by the attachment tabs. Lines should not be attached with a lark's foot as this significantly reduces their strength. If you are unsure of the correct procedure, always consult with a professional.

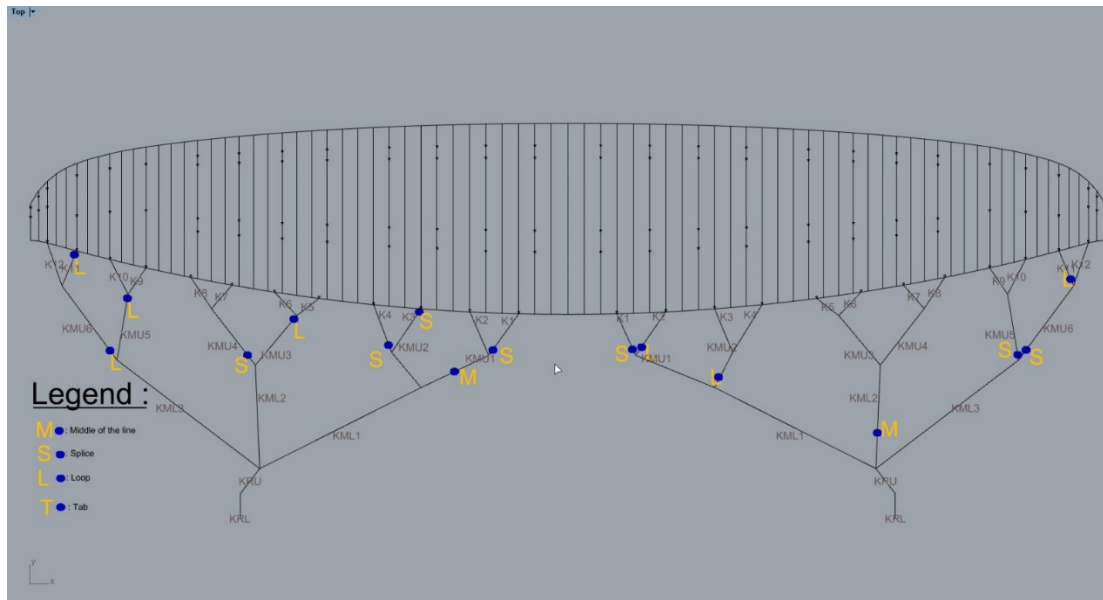
The brake lines were also completely detached from the canopy, Group2 left side has broken in the middle of a lowest line so probably from AR2 or BR2 breaking whiplash. The rest of the brake fan is broken on upper lines or middle upper lines, probably the same “unzipping” mode than the rest of the lines.
